## Inspection Report

**Property Address:**  
123 Anywhere Street  
Moab, Utah 84532

**Inspections Unlimited LLC**

<b>Date:</b> 9/19/2006	<b>Time:</b> 5:30 PM	<b>Report ID:</b> 999
<b>Property:</b> 123 Anywhere Street Moab, Utah 84532	<b>Customer:</b> John Doe	<b>Real Estate Professional:</b>

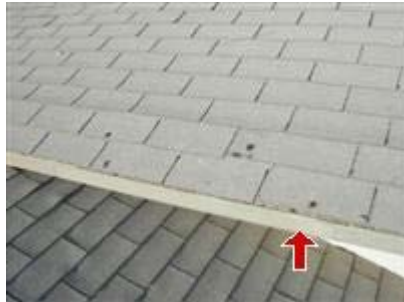
1.0 Picture 1

Some repairs have been made to the shingles. (Picture 1) There are also some damaged shingles. (Picture 2)

Some repairs have been made to the shingles. (Picture 1) There are also some damaged shingles. (Picture 2)

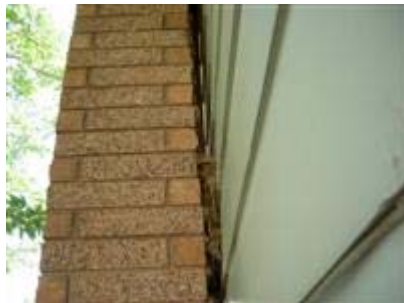
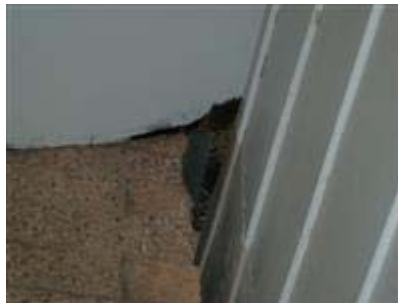
1.2 Picture 1

The chimney is pulling away from the house. (Picture 1) (Picture 2) I made the chimney move while I was on the roof. It is not attached to the home. I couldn't tell if there was an adequate foundation under the chimney or not. I do think it could be pulled back into place and secured to the home. I suggest you talk with a professional about repairs.

**Comments:** Inspected, Repair or Replace  
As I mentioned earlier the chimney is moving.

The chimney is pulling away from the house.(Picture 1) (Picture 2) I made the chimney move while I was on the roof. It is not attached to the home. I couldn't tell if there was an adequate foundation under the chimney or not. I do think it could be pulled back into place and secured to the home. I suggest you talk with a professional about repairs.

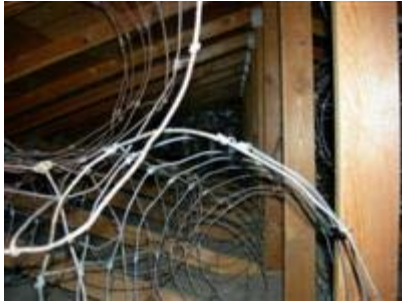
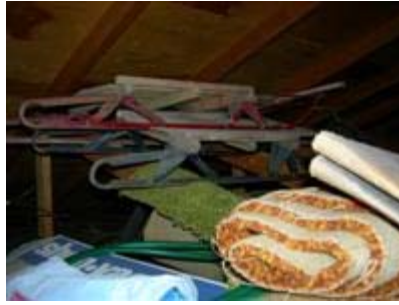
1.5 Picture 1

I could not gain access into the upper attic, there is a permanently mounted shelf in the way. The attic above the carport is being used for storage which limits access. (Picture 1) (Picture 2) From what I could see it all looks ok.

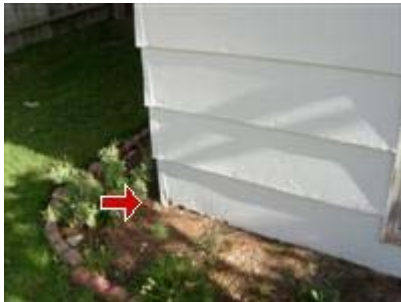
2.0 Picture 1

On the east end of the home the siding is in the soil and is quite wet. (Picture 1) This can lead to mold and/or insect problems. There is a small place next to the roof that has some old moisture damage. It is dry now. I recommend talking with a professional.

On the east end of the home the siding is in the soil and is quite wet.(Picture 1) This can lead to mold and/or insect problems. There is a small place next to the roof that has some old moisture damage. It is dry now. I recommend talking with a professional.

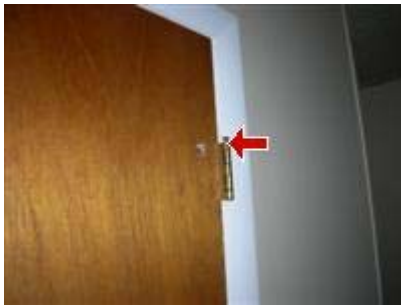
4.3 Picture 1

**Comments:** Inspected, Repair or Replace  
The pantry door has a hole in it. (Picture 1)

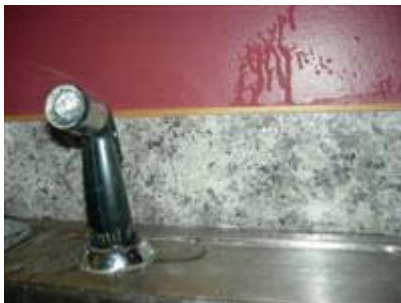
4.7 Picture 1

**Comments:** Inspected, Plumbing Repair or Replace  
The hand sprayer leaks.(Picture 1) I suggest you contact a licensed plumber.

The hand sprayer leaks.(Picture 1) I suggest you contact a licensed plumber.

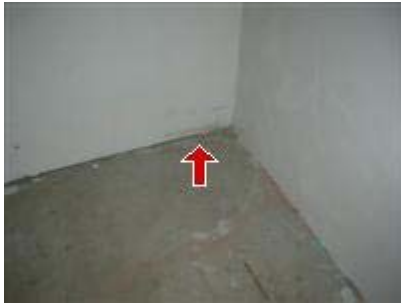
5.1 Picture 1

There seems to be moisture behind the sheetrock and under the carpet in the basement. (Picture 1) I was able to get a reading with the moisture meter pretty much anywhere below three feet in height. (Picture 2) The highest readings were in the storage room and under the windows in the family room. I recommend contacting a professional.

There seems to be moisture behind the sheetrock and under the carpet in the basement. (Picture 1) I was able to get a reading with the moisture meter pretty much anywhere below three feet in height. (Picture 2) The highest readings were in the storage room and under the windows in the family room. I recommend contacting a professional.

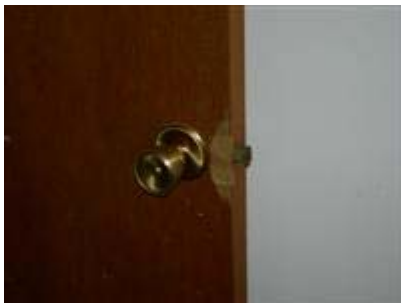
5.4 Picture 1

The door to the pink bedroom sticks. That is probably what caused the damage.(Picture 1)

The door to the pink bedroom sticks. That is probably what caused the damage.(Picture 1)

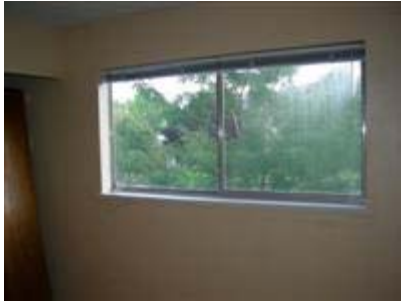
5.5 Picture 1

One of the bedroom windows has had a pane of glass broken, so it is no longer insulating. Quite a few of the windows have had the seals go bad. (Picture 1) I suggest contact a window professional.

One of the bedroom windows has had a pane of glass broken, so it is no longer insulating. Quite a few of the windows have had the seals go bad. (Picture 1) I suggest contact a window professional.

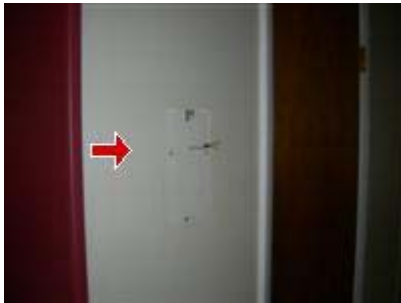
5.6 Picture 1

**Comments:** Inspected, Electrical Repair or Replace  
The phone jack in the hall way has been removed.(Picture 1)

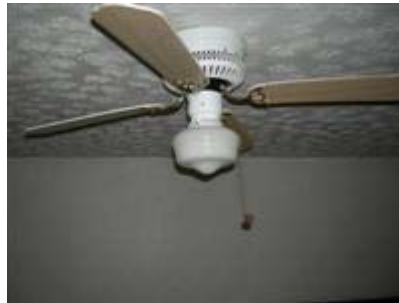
5.6 Picture 2

The light switch on the fan in the basement is very stiff. You may want to contact an electrician.

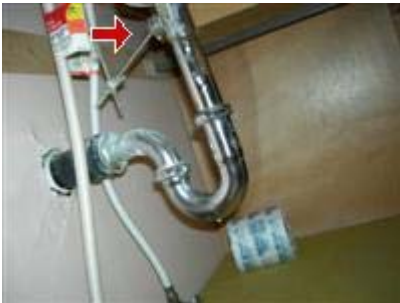
6.6.A Picture 1

The drain plug valve is leaking under the sink.(Picture 1)

The drain plug valve is leaking under the sink.(Picture 1)

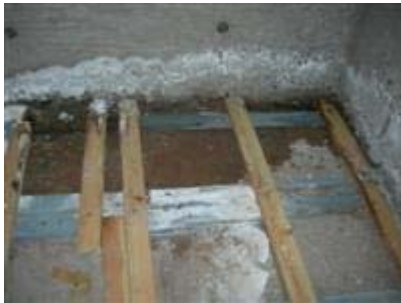
7.0 Picture 1

There is water getting into the crawlspace in the north west corner.(Picture 1)

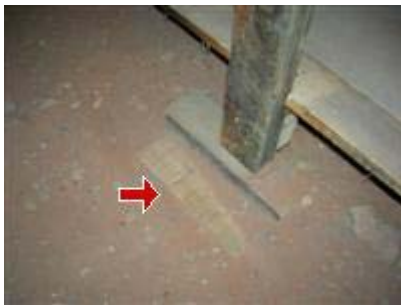
7.2 Picture 1

Some of the shelving is sitting in the dirt. (Picture 1) This can lead to termites or other problems. I suggest you contact a professional.

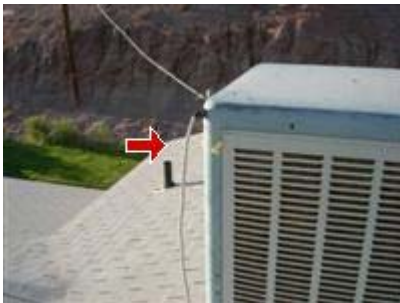
10.8 Picture 1

**Comments:** Inspected, Repair or Replace  
The wiring for the swamp cooler is not in conduit and is decaying in the sun.(Picture 1) I suggest you contact a licensed professional.

The wiring for the swamp cooler is not in conduit and is decaying in the sun.(Picture 1) I suggest you contact a licensed professional.
